Drinking water requirements for lactating dairy cows (2001)

DRINKING WATER REQUIREMENTS FOR LACTATING DAIRY COWS

Summary

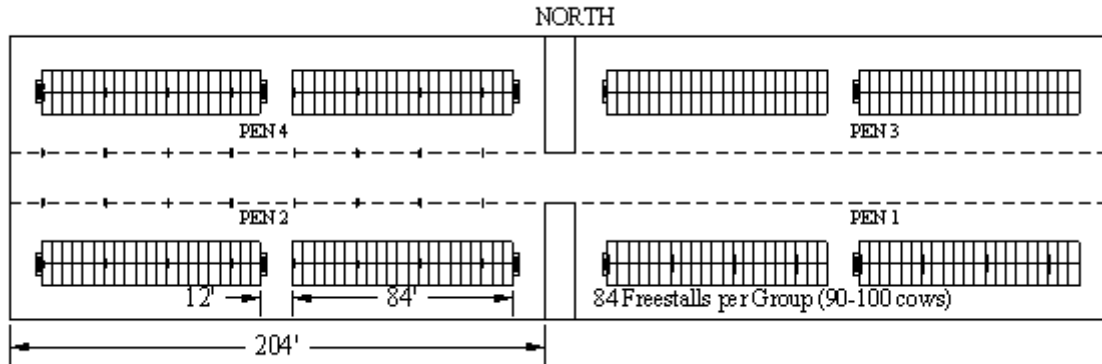
Figure 1. Layout of Pens and Location of Water Troughs ☒ in a 4-Row Freestall Building.

Three dairies were selected in north central Kansas for this study during the summer 2000. At the first dairy, Holstein cows were housed in a 4-row freestall barn, milked 2 \times and milk production averaged 72 lb/cow/day. Each pen contained 84 freestalls with a stocking density of 110%. Figure 1 shows the placement of the water troughs in the 4-row freestall building. Fans and a feedline sprinkler system were used for heat abatement. Walking distance from the back of the milk parlor to the housing area was less than 150 ft. Water space available was 3 cows per linear ft of trough.

The third dairy utilized Jersey cows producing an average of 65 lb of milk/cow/day. The herd was housed in a 4-row freestall barn and milked 2×. Building layout was similar to Figure 1 except the pens housed cows in different stages of lactation. Each pen housed 40 cows. The walking distance from the milking parlor to the freestall housing area was 30 ft. The water troughs were not emptied on a routine basis for cleaning at this dairy.

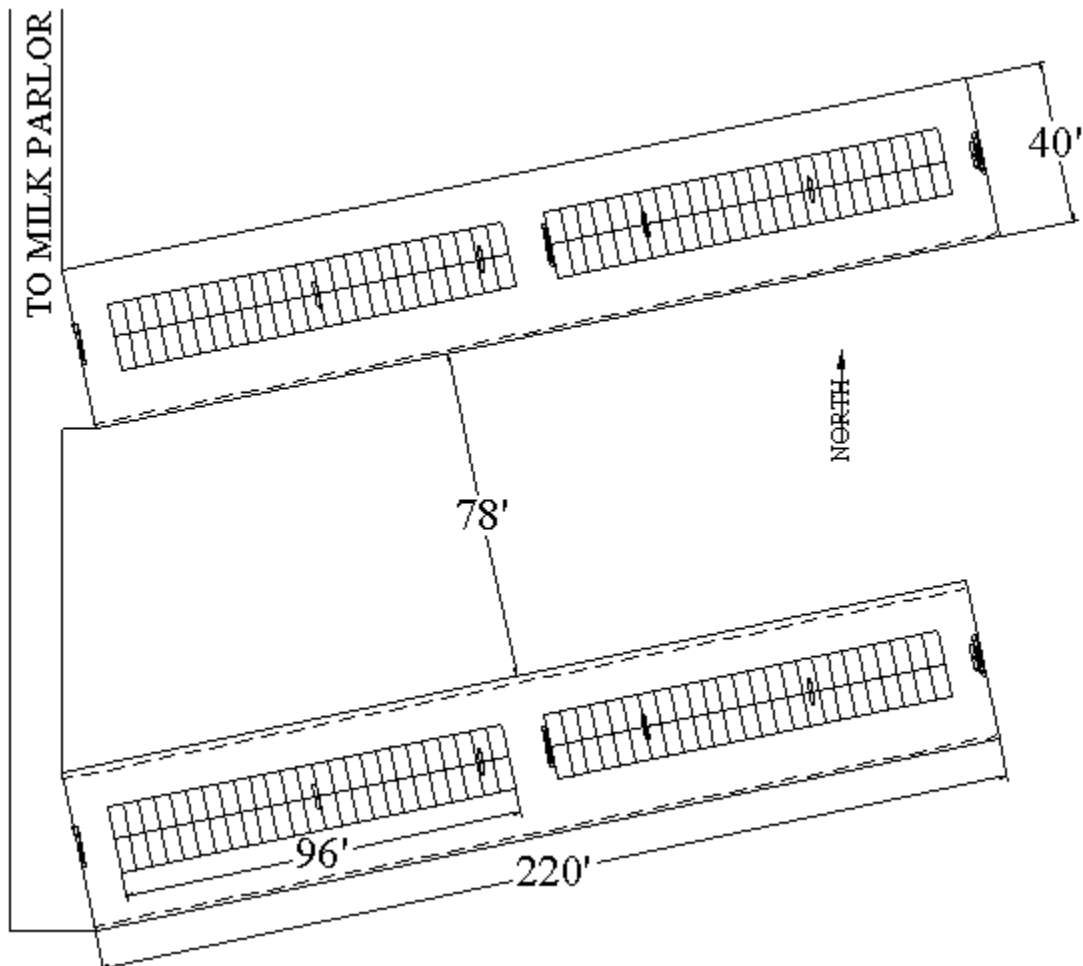
Figure 2. Layout of 2-Row Freestall Buildings and Location of Water Troughs ☒.

3× and milk production averaged 78 lb/cow/day. Figure 2 shows the water trough location in the 2-row freestall facility. The milk parlor was a double 12 parlor with two exiting lanes. Water troughs were located on the east and west side of a common exit lane and were equipped with water meters. Cows had to walk 400 to 500 ft from the milking parlor to the freestall buildings. Each freestall had 108 freestalls and was stocked at 100% capacity. Water space available was 3.6 cows per linear ft.

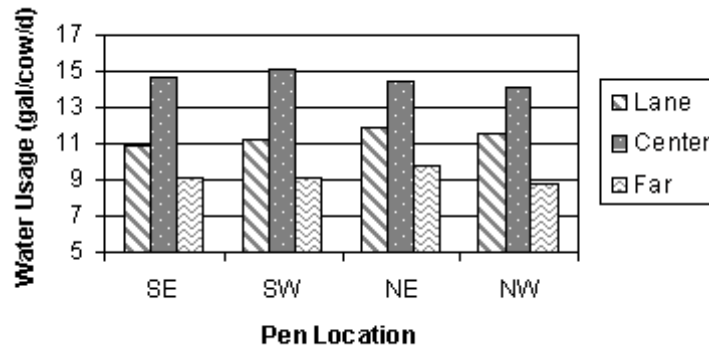
Figure 3. Total Daily Water Disappearance from Water Troughs in Different Pens in a 4-Row Freestall Building Populated with Holstein Cows.

Water usage at the first dairy (Figure 3) averaged 35.1 gallons/cow/day including the water used to refill the tanks after dumping. Figure 4 shows the water usage in each of the four pens. Higher producing cattle were located in the SW and NE pens. Over 40%

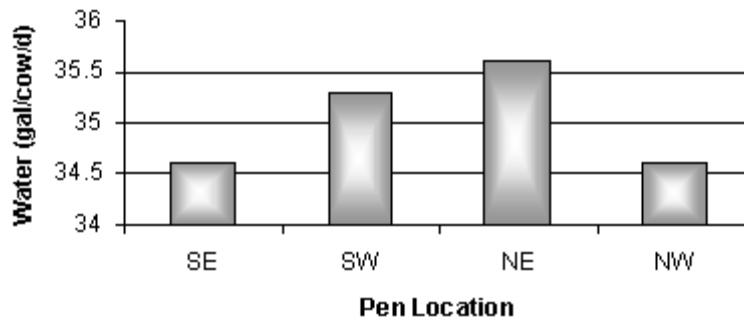
Figure 4. Water Disappearance from Water Troughs Located in Different Sections of a 4-Row Freestall Building Populated with Holstein Cows.

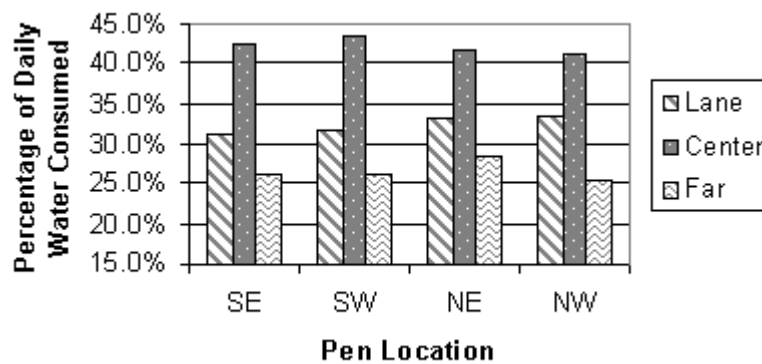
Figure 5. Percent Water Disappearance from Water Troughs Located in Different Sections of a 4-Row Freestall Building Populated with Holstein Cows.

of the water was consumed from the water trough located in the center cross alley (Figure 5). The water trough located farthest from the travel lane to the milk parlor had the lowest usage. Approximately 4.8 gallons/cow/day were needed to refill the water tanks after tipping. This represented 14% of the total daily usage in the freestall housing area, excluding water used for heat abatement.

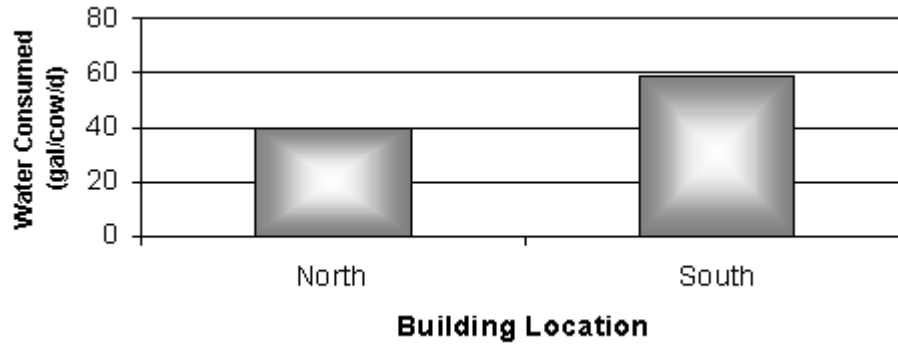
Figure 6. Total Daily Water Disappearance in 2-Row Freestall Buildings Populated with Holstein Cows.

Figure 6 shows the daily water usage for the 2-row freestall buildings located on the second dairy. Data from the north pen more accurately reflected the water usage of this herd at 40.2 gallons/cow/day plus an additional 3.5 gallons/cow/day at the milk parlor water tank. Data from the south pen shows the impact of a leaking water line (Figure 7). Average water usage per cow increased from 40.2 to 58.9 gallons/cow/day. This represented nearly a 50% increase in water consumption during the study period. Figure 7 shows the water usage at the individual water troughs in the north and south buildings. The water meter reveals the impact of the leaking water line at the water trough farthest from the travel lane in the south building. Water usage at the center water trough and water trough near the travel lane were similar. Approximately 6.7 gallons/cow/day were used in refilling the tanks after tipping. This represented 15% of the total daily water usage in the housing area.

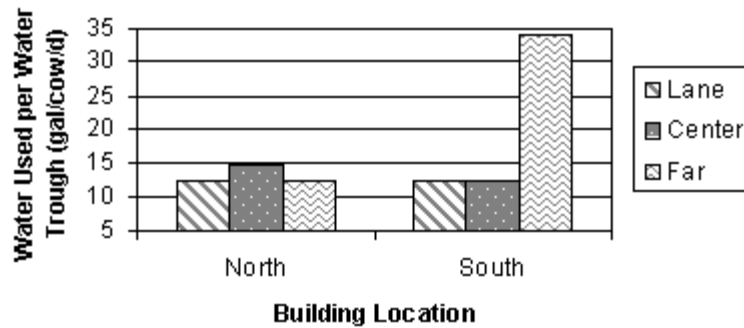
Figure 7. Water Disappearance from Water Troughs Located in Different Sections of a 2-Row Freestall Building Populated with Holstein Cows.

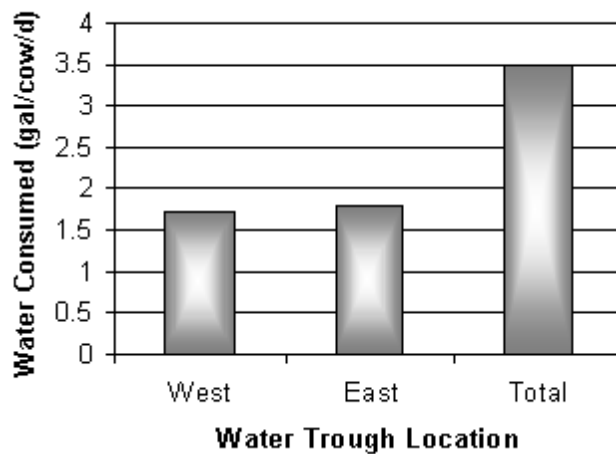
Figure 8. Water Consumed by Holstein Cows at Water Troughs Located at Milk Parlor Exit.

Figure 8 shows the water usage at the water troughs located in the milk parlor exit lanes at the second Holstein farm. There was no difference between the usages of water in the west or east exit parlor lane. The total water usage at the exit lane was approximately 3.5 gallons/cow/day or about 8% of their daily consumption.
