Kansas Agricultural Experiment Station Research Reports

Drinking water requirements for lactating dairy cows

DRINKING WATER REQUIREMENTS FOR LACTATING DAIRY COWS

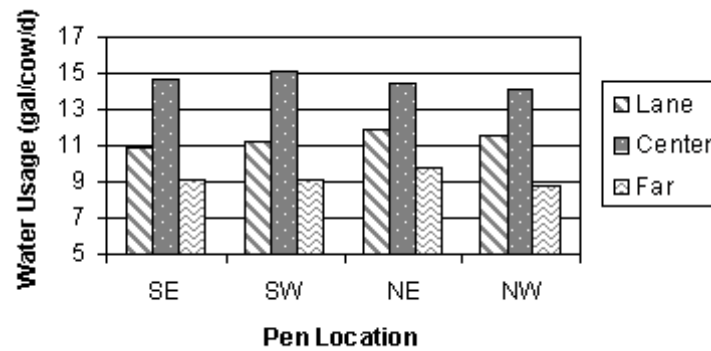
Figure 3. Total Daily Water Disappearance from Water Troughs in Different Pens in a 4-Row Freestall Building Populated with Holstein Cows.

Water usage at the first dairy (Figure 3) averaged 35.1 gallons/cow/day including the water used to refill the tanks after dumping. Figure 4 shows the water usage in each of the four pens. Higher producing cattle were located in the SW and NE pens. Over 40%

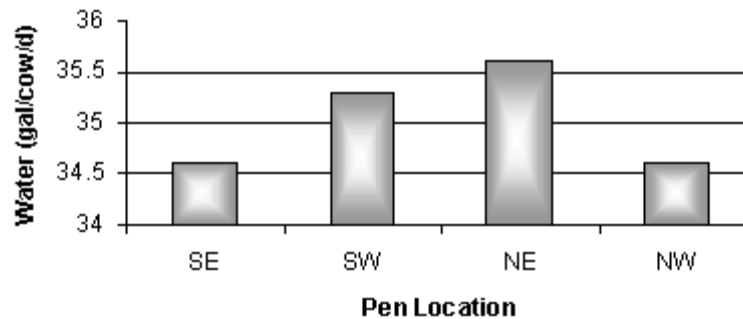
Figure 4. Water Disappearance from Water Troughs Located in Different Sections of a 4-Row Freestall Building Populated with Holstein Cows.

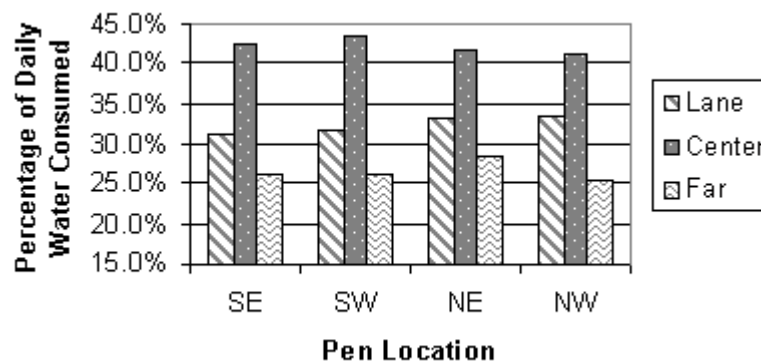
Figure 5. Percent Water Disappearance from Water Troughs Located in Different Sections of a 4-Row Freestall Building Populated with Holstein Cows.

of the water was consumed from the water trough located in the center cross alley (Figure 5). The water trough located farthest from the travel lane to the milk parlor had the lowest usage. Approximately 4.8 gallons/cow/day were needed to refill the water tanks after tipping. This represented 14% of the total daily usage in the freestall housing area, excluding water used for heat abatement.

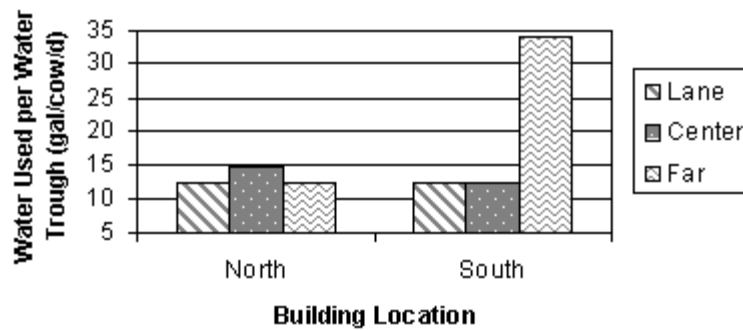
Figure 7. Water Disappearance from Water Troughs Located in Different Sections of a 2-Row Freestall Building Populated with Holstein Cows.

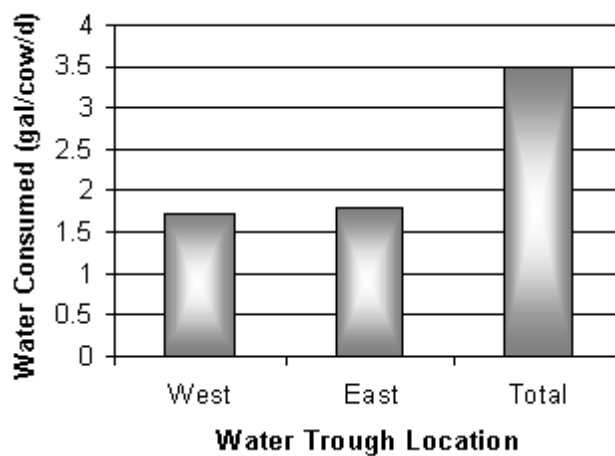
Figure 8. Water Consumed by Holstein Cows at Water Troughs Located at Milk Parlor Exit.

Figure 8 shows the water usage at the water troughs located in the milk parlor exit lanes at the second Holstein farm. There was no difference between the usages of water in the west or east exit parlor lane. The total water usage at the exit lane was approximately 3.5 gallons/cow/day or about 8% of their daily consumption.
