Protect Streambanks with Trees

PROTECT STREAMBANKS WITH TREES

W.A. Geyer, T. Neppl, and K. Brooks*

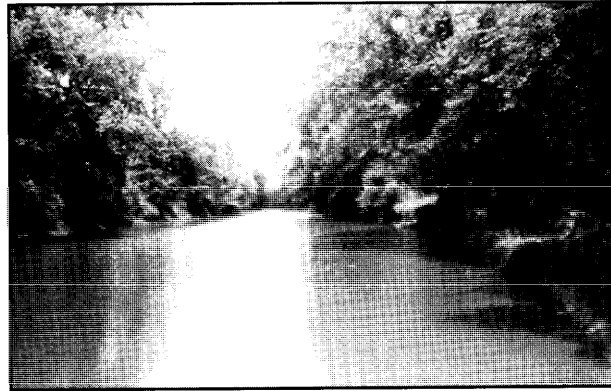
Figure 4. Natural woody vegetation should be left to protect streambanks.
