## Evaluating the Effect of Manufacturing Porcine Epidemic Diarrhea Virus (PEDV)-Contaminated Feed on Subsequent Feed Mill Environmental Surface Contamination

## Evaluating the Effect of Manufacturing Porcine Epidemic Diarrhea Virus (PEDV)-Contaminated Feed on Subsequent Feed Mill Environmental Surface Contamination<sup>1</sup>

### Summary

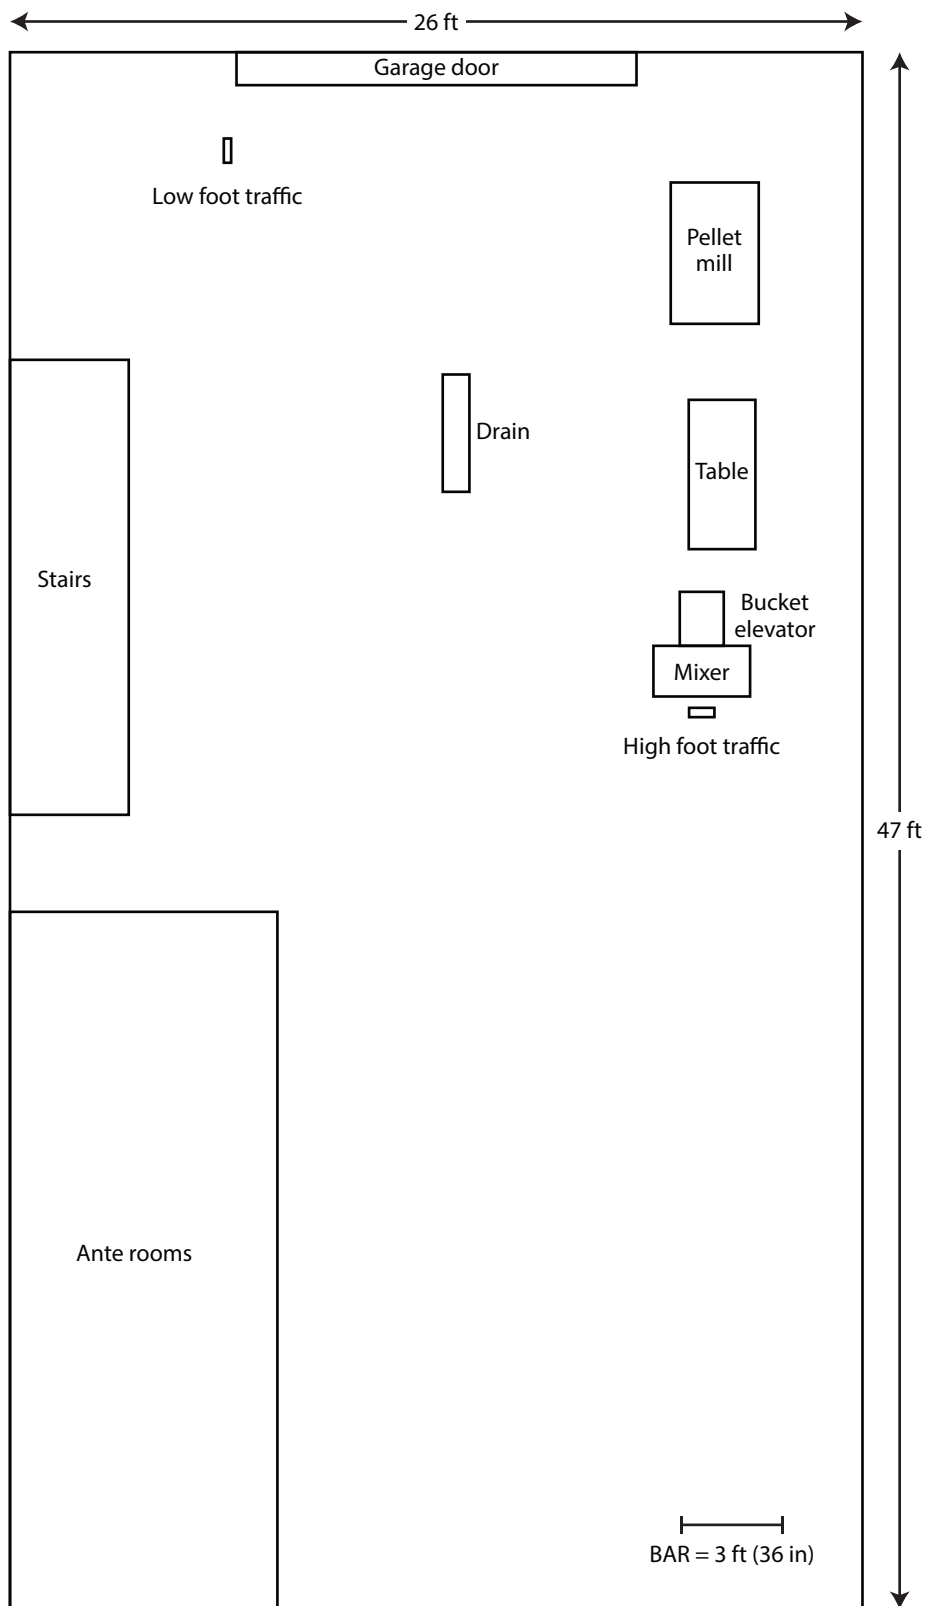
**Figure 1. Arrangement of the first floor of the Kansas State University Cargill Feed Safety Research Center. Designated areas swabbed for PEDV PCR analysis include high and low foot traffic areas, drain, garage door, pellet mill, table ledge, bucket elevator, and feed mixer as well as rubber boot bottoms.**

The same large foam tipped swabs used for the baseline PEDV-determination were also used to swab designated locations after discharge of the negative control, positive control, and Sequences 1 through 4 for each replicate. Swabs were categorized by sampled material or type of environmental surface from specific locations (Figure 1). Briefly, concrete surfaces included a floor drain, high foot traffic, and low foot traffic area. Metal surfaces included a vertical garage door surface and horizontal table ledge. A rubber surface was the bottom tread of a boot worn during the experiment. Equipment surfaces included metal feed mixer paddles, metal mixer bottom, metal interior of the mixer lid, plastic interior of a bucket elevator, and the rubber bucket elevator belt adjacent to sampled buckets. After completion of Sequence 4 and after pelleting the positive batch, the pellet mill was allowed to cool, disassembled, and swabs were collected at the metal interior of the pellet mill hopper, metal interior of the mash conditioner, metal feeder screw, metal die interior rim, and metal die exterior shroud. All swabs were again collected from the same designated surfaces after physical cleaning, and the two steps of chemical cleaning, and heat-up.

The environmental swabbing sampling areas were outlined in heat-stable marker when possible to form five subsampled areas. Subsampled areas within a location were equal in size; however, the areas ranged from approximately 2.3 in<sup>2</sup> to 6.5 in<sup>2</sup> between locations. Subsampled areas within location were randomly allocated to be sampled after the negative control, positive control, and Sequence 1 to 4 feed treatments were manufactured. Thus, one subsampled area was swabbed per treatment and no subsampled area was sampled twice during each replication. Prior to the manufacturing of the negative control and after step two of chemical cleaning and heat-up, the entire surface of all five areas were swabbed to establish and confirm baseline levels.
