Constructed Landscape

Joy House Project

Michael Hughes

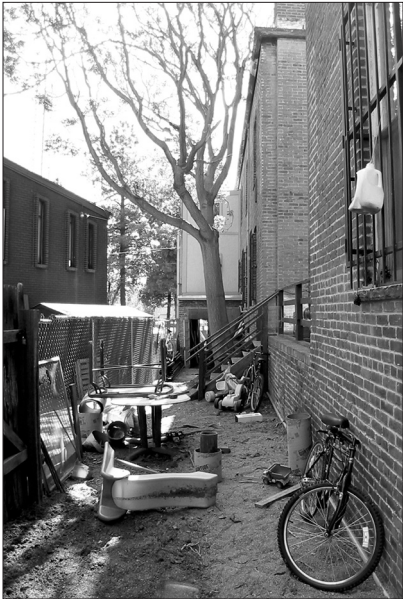
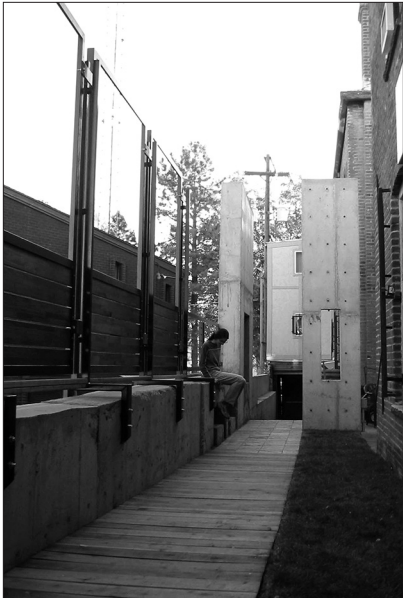
Before, above and after, below

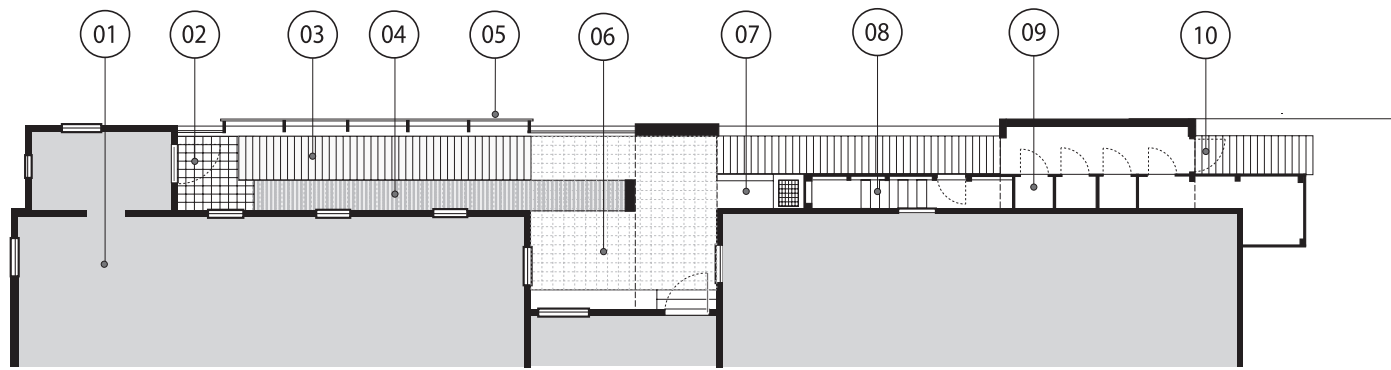
Key: 1 Daycare, 2 Landing, 3 Ramp, 4 Grass Play Area, 5 Privacy Screen, 6 Courtyard, 7 Barbecue, 8 Boiler Room, 9 Storage, and 10 Entry

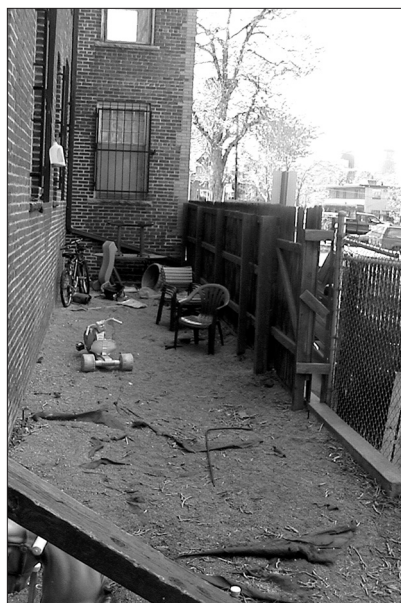
Ramp to west, before

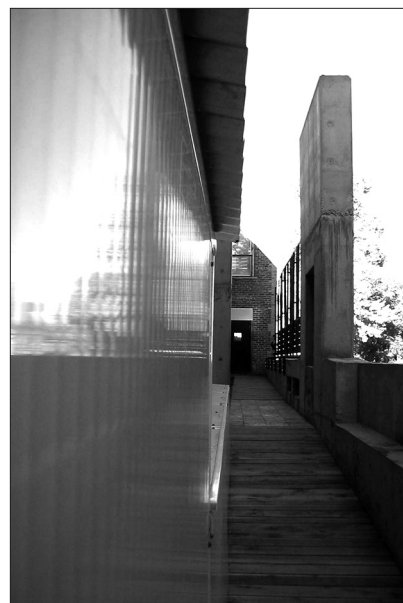
Ramp to west, after
